# Sulfuric Acid

Fall/Winter 2016

# Finding the root cause of acid carryover

By: Vitor A. Sturm<sup>1</sup>, Bruno B. Ferraro<sup>1</sup>, Michael D. Montani<sup>1,2</sup>, and Nelson P. Clark<sup>1</sup>

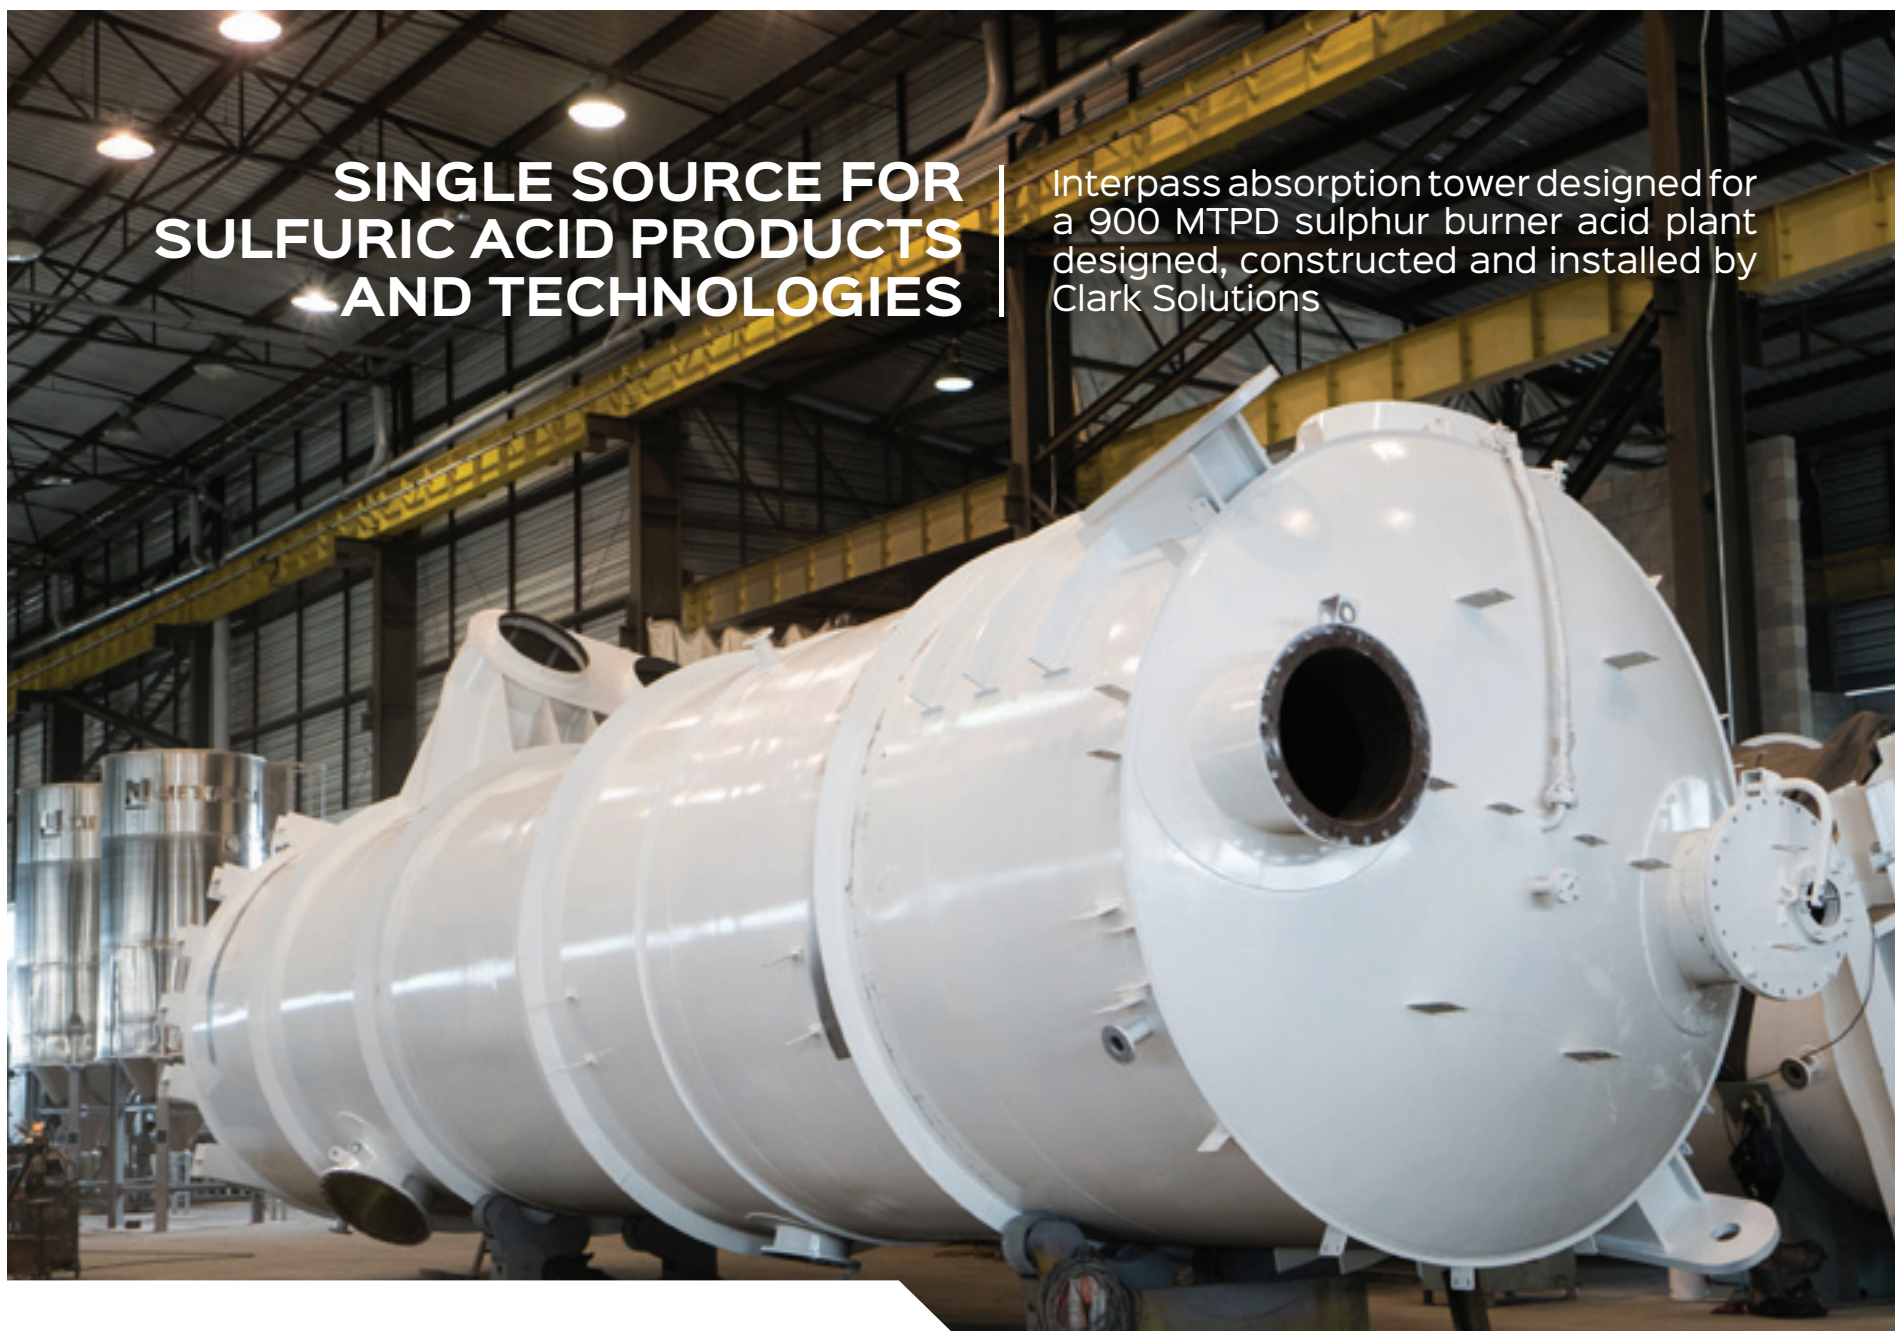
Interpass absorption tower designed for a 900 MTPD sulphur burner acid plant designed, constructed and installed by Clark Solutions

- **Mist Eliminators:** MaxiMesh® wiremesh and FiberBed® fibre bed
- **Acid Distributors:** Through & Downcomers and Pipe Distributors
- **Tower Internals:** MaxiSaddle® ceramic packing and MaxiDome® ceramic support

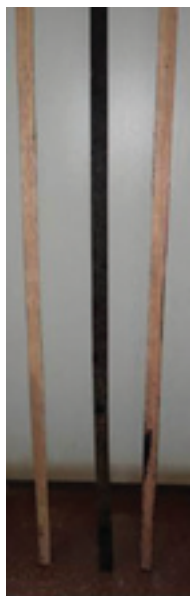
Fig. 1 shows, from left to right, a 1-minute stick test realized at the drying (DT), interpass (IPAT), and final (FAT) towers of a 600 MTPD sulfur burning sulfuric acid plant. It is easy to see that the IPAT was operating with significant carryover—the stick was so dark and wet that it is almost impossible to pinpoint possible causes. A major mist eliminator vendor immediately suggested that candles were not working properly and that replacement was necessary.

Fig. 1: Original stick test.

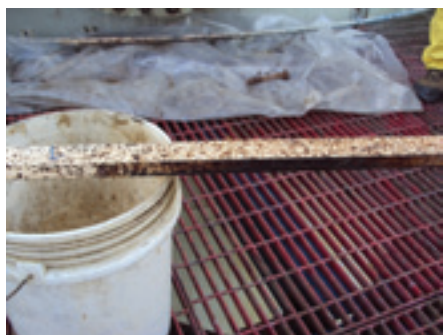
Stick tests, as shown in Figs. 1 and 2, are the simplest qualitative way to reveal fine mist carryover and/or acid droplet re-entrainment (dark wet spots), an inefficient SO<sub>3</sub> absorption, or submicron mists (uniform wood burn) inside an absorption or drying tower. An ideal stick test retrieves a clean stick.

Fig. 2: Closer stick test view shows dark spots (acid droplets).

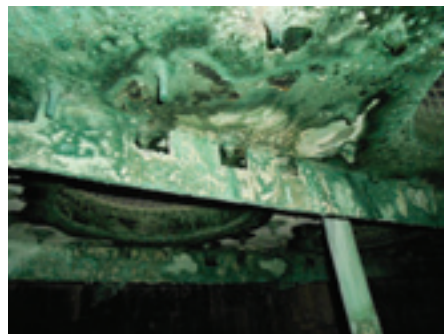
Fig. 3: Tube sheet support beams cut to fit bolts.

In September 2015, the plant was shut down for a brief inspection. The IPAT inspection identified several cuts along the support beams, most probably because of a modification to fit candle filters that were acquired with different flange bolting hole patterns. Originally, the tube sheet was designed to support seventeen candles with 16 flange bolts on each candle. However, a different situation was found, with a mix of 12 and 16 flange bolts as well as two blockages at tube sheet center. When observing these conditions there was suspicion of possible tube sheet warping.

In January 2016, the plant was shut down for a brief inspection prior to the new tube sheet installation. Due to both the mist eliminators' weight in operation and the support beams' "cut windows" (Fig. 3), the tube sheet showed warping, creating

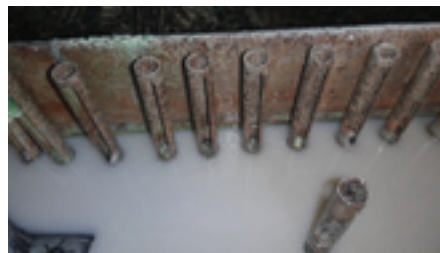
Most downcomers were heavily fouled, directly affecting acid flow on distribution troughs. This caused heavy acid overflow and resulted in intense acid-mechanical carryover toward candles that overloaded due to draining capacity. All downcomers were cleaned and/or repaired.

Fig. 5: Fouled downcomers.

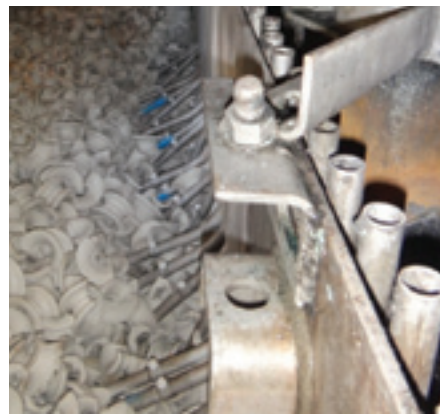
Downcomer extensions are attached by pins that must be properly designed to avoid fouling. Teflon pins are shown in Fig. 6. Properly designed pins keep debris that may be circulating with the acid from blocking the downcomers. All pins were replaced with Clark Solutions designed pins.

Improper trough fixation can result in unbalanced troughs, which causes vibration and damage, and results in acid spills and carryover.

Fig. 6: Downcomer pins and trough fixation.

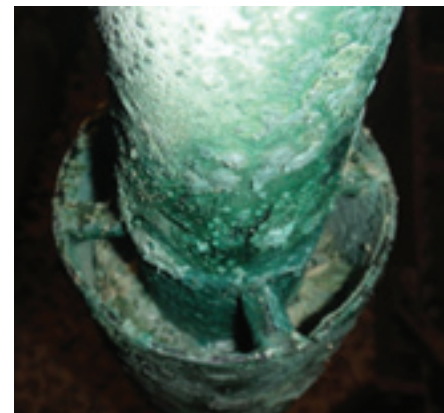
All IPAT tube sheet drain seal legs were completely fouled and blocked by sulfate, preventing continuous drainage of collected acid by the tube sheet mist eliminators. At the time, the only way to drain collected acid was through a side drain, which operators opened once every shift. All draining seals were changed with newly designed ones, properly sized for the operating pressure drops in a more open design to reduce fouling effects.

Fig. 7: Old draining seals.

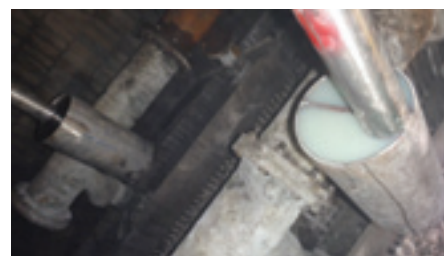
Fig. 8: Installed new draining seals.

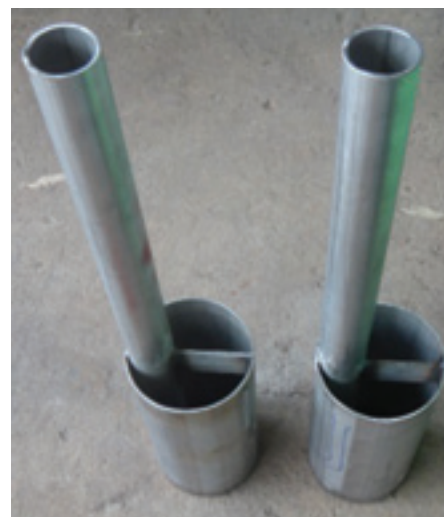
Fig. 9: New draining seals.

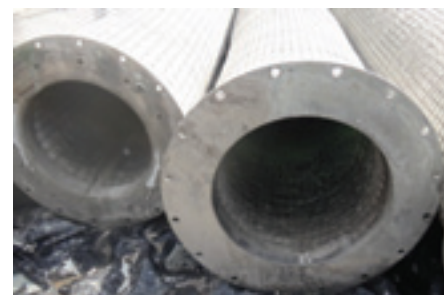
Since there were candles of different types and suppliers inside the IPAT, there was not a pattern on the mist eliminators. Fig. 11 shows two hole patterns on the same flange. In addition, some candles included an internal reinforcement structure and others did not.

Fig. 10: Old candles with different hole patterns and internal structure.

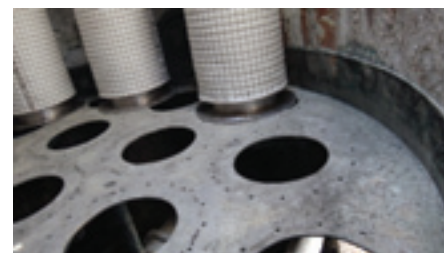
Fig. 11: New Fiberbed® with pedestals to fit different hole patterns.

In September, 18 Fiberbeds® were bought from Clark Solutions. Because a new tube sheet with one single candle bolting hole pattern was scheduled to be installed in 2016, the candles were designed and built with a stainless steel pedestal so that they

could be adapted and reused in the future.

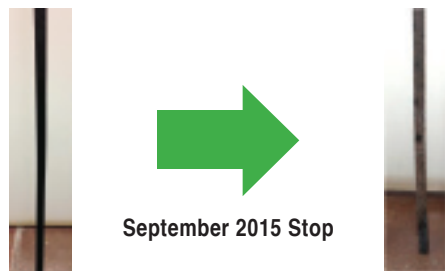
Due to the short working timeframe in September, it was not possible to implement further actions. After starting the plant, a new stick test was conducted. The improvements were noticeable, but not complete, so another inspection was scheduled for January.

Fig. 13: Stick test comparison for first intervention.

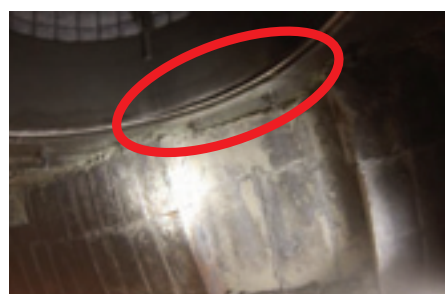
Fig. 15: Warping detail.

The January inspection revealed that the Teflon gaskets on some filter candles were clearly not tight, indicating warping and gas passage. Fig. 15 shows that even anti-acid bricks were removed to fit bolting. Even 6 mm full face Teflon gaskets were not able to correct the spacing caused by the tube sheet warping, confirming that a new tube sheet was necessary.

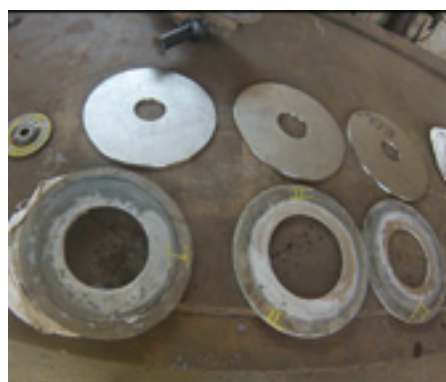
Fig. 17: Old (below) and new (above) orifice plates.

in the IPAT acid troughs, new flow-control orifice plates were designed. Differences in the plate designs are shown in Fig. 17. The plates were changed during the January inspection. After these orifice plates' modification, smoother flow was observed over all acid troughs, eliminating overflow and minimizing acid entrainment.

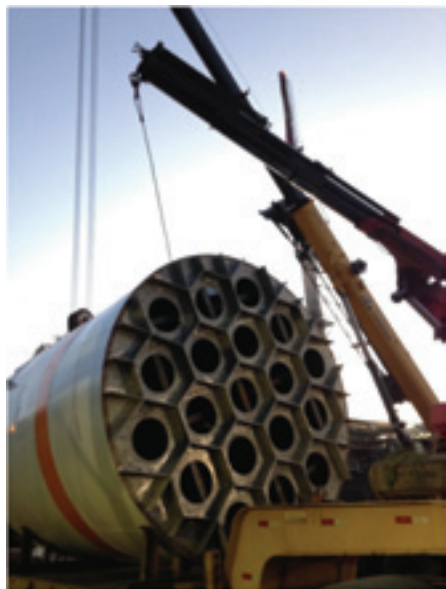
Fig. 19: New tower head with new tube sheet.

Because of the warped and damaged structure of the IPAT tube sheet, a full replacement was made in May 2016. The new tube sheet was designed to evenly support 19 filter candles as shown in Fig. 19.

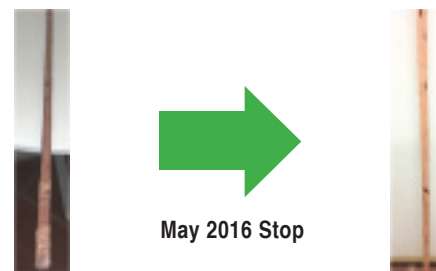
After the tube sheet replacement, a proper stick test was finally achieved. The black marks in the final stick test are typically seen as a result of acid residue in the

Fig. 20: Stick test comparison for final intervention.
